# Experimental Investigation of Brick Masonry Arches' (Vault and Rib cover) Behavior Unreinforced and Reinforced by C-FRP under vertical and Horizontal Load Simultaneously

*In this paper, two masonry structures including the arc and the beam in real dimensions under simultaneous vertical and lateral loading will be examined. Vertical load was applied on the spring and then lateral load applied at the arch to the base. In the first experiment, the sample was loaded without reinforcement, and according to the results, the second sample was reinforced with polymer fiber C-FRP and subjected to similar loading. According to the results in the first sample, the first cracks appeared at the site of force stretch to the structure. Therefore, carbon fiber was used to reinforce the vulnerable areas. The reinforced structure was able to show very high stability against lateral forces, with the displacement rate at various points of the structure being significantly reduced. Structural load capacity also increased 13KN.*

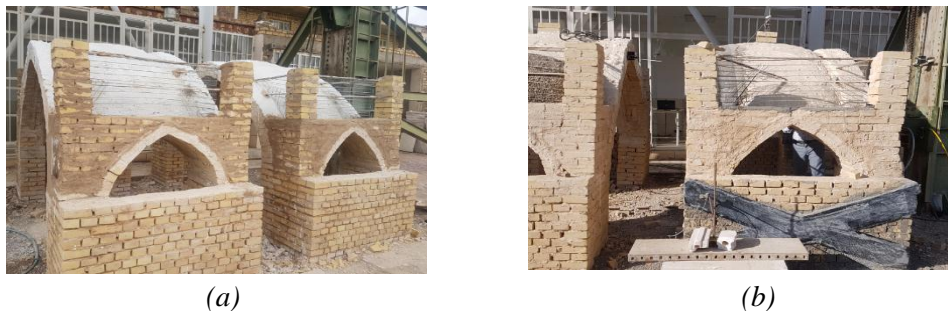
Figure 3. The stages of construction structure: a) Structure view of arch and rib cover; b) Structural view after reinforcement.

The structure of this study consists of vault and rib cover on top of the base. The arch is of a six-part type. The diameter of the arc is 240 cm and 95 cm. vault and rib cover structure is located on the base with 100 cm high. To attach the base holder to the ground, the site was secured by a cement mortar and bolt, with 30 cm x 30 cm x 1 cm sheets, and welded on 4 rebar to prevent the structure from reacting to the applied force. For each structure, two bushings (lenge) are used for vaults and two smaller bushings for springs are used to attach bushings as well as arch joints. After fitting, brick and mortar were used to make springs and vaults. The specimen in the first experiment without reinforcement is subjected to vertical and horizontal simultaneous loading. Using the results of the first experiment, the second structure are reinforced with carbon fiber polymer strips and applied to the reinforced structure in the same way.

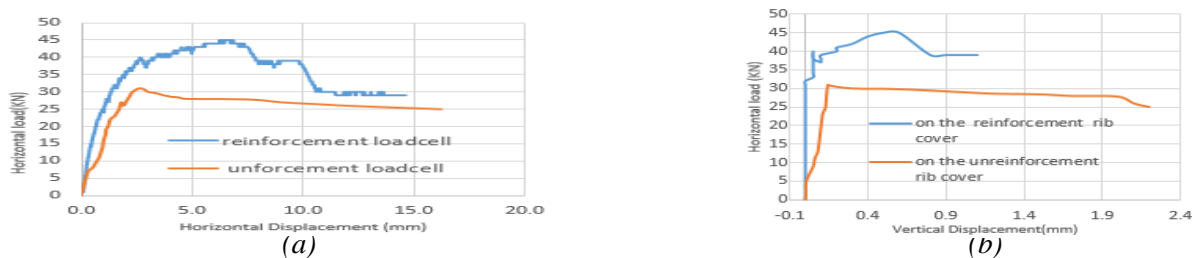
Figure 10. Comparison of the force-displacement diagram in reinforced and un reinforced structures: a) Horizontal displacement b) Vertical displacement.

Force-displacement in reinforced structures that sensitive and damage points were reinforced with C- polymer fiber strips C- FRP to compare with non-reinforced structures. Comparison of force-displacement diagrams under vertical loading due to low displacement rates was excluded, but under horizontal loading the displacement at the top of the front of the vault in the reinforced structure has increased about 5/5%.
